5th International Conference
Youth in **Conservation** of **Cultural Heritage**
21st-23rd September 2016 - Madrid -

Book of abstracts

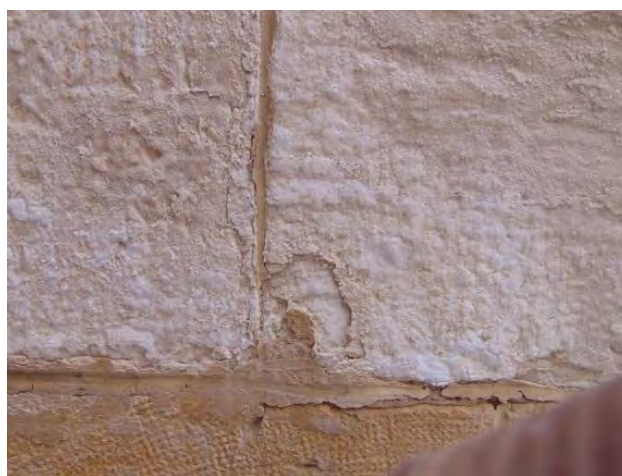
Figure 1. The effect of salt weathering on the stone surface

Al- Azhar is one of the oldest mosques in historic Cairo. It was founded by the Fatimids in 970 AD. The mosque is constructed mainly with dolomitic limestone. Al-Azhar mosque shows various forms of deterioration, such as flaking and breakdown of stone surface. These deterioration forms are related mainly to the presence of salts within the stone material (Fig.1).

The results showed that salts are found in both outdoor and indoor samples and the concentration of salts (mainly chlorides, sulfates and nitrates) increased in the deteriorated samples.

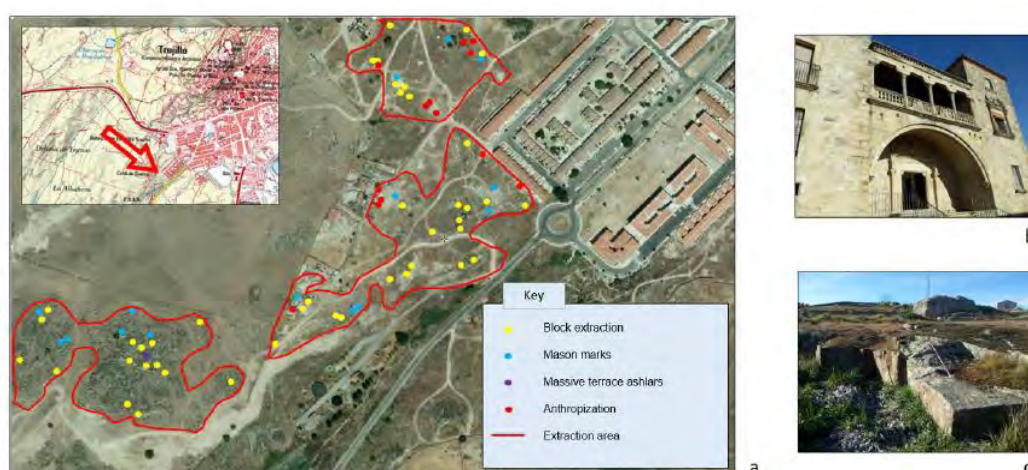
Figure 1. a. Historic extraction area. Identification and georeferencing information of tool marks. B. Juan Orellana Pizarro Palace. Trujillo. C. Historic extraction area associated with the architectural heritage of Trujillo (Cáceres)

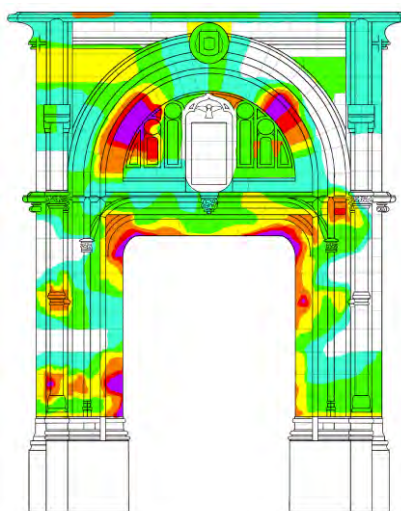
Figure 2. Mapping of initial salt content

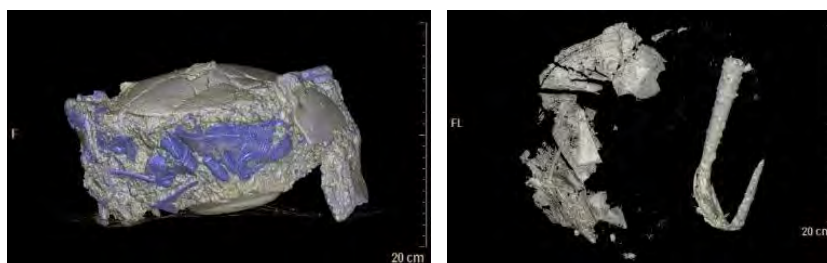
Figure 1. Two visions of tomography of the funerary urn of Les Esquarterades

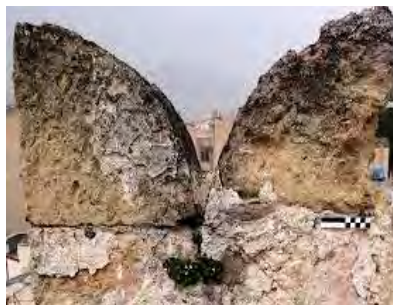
Figure 2. Detail of the stone decay

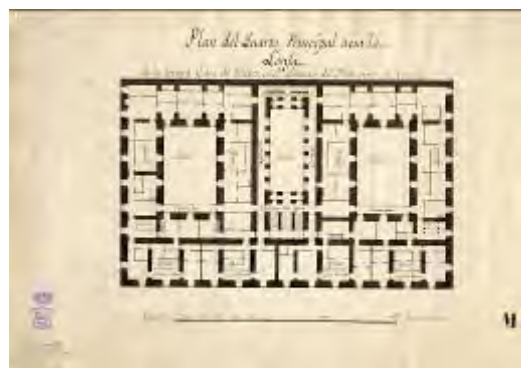
Figure 2. Original plan of Juan de Villanueva

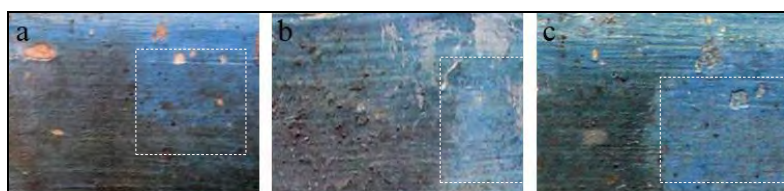
Fig. 1 Comparison between biocleaning after a) 8 h and b) 24 h; and c) chemical cleaning

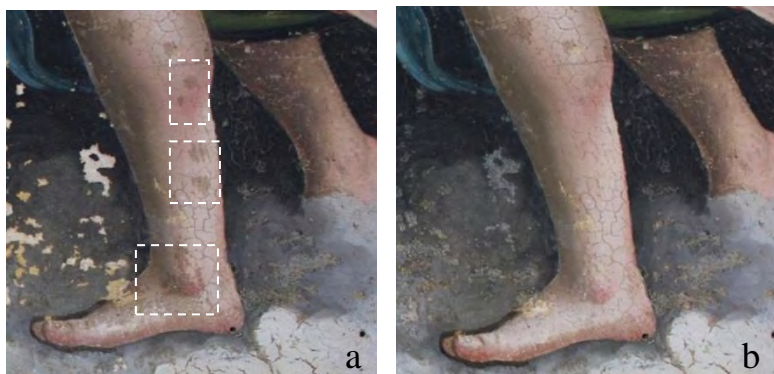
Fig. 2 Treatment with Er:YAG laser: a) before and b) after the cleaning

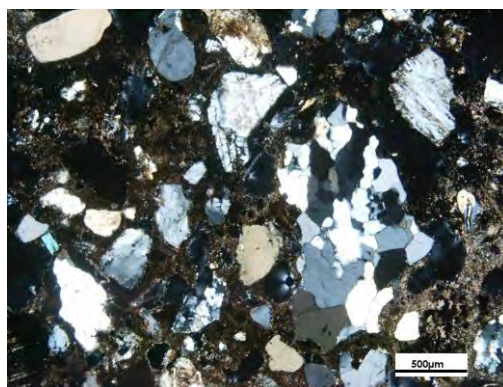
Figure 2. Photomicrograph of mortar sample from the wall of the temple (Cross nicols, 4x)

The results of the analyses reveal that all samples have variety of igneous and metamorphic rock fragments and angular to semi-angular quartz feldspar biotite aggregates embedded in a carbonated lime binder (Fig 2). Colors of mortar samples vary in white-yellow range with high luminosity. Microscopic and XRD analysis results reveal the micritic calcitic binder and quartz feldspar and biotite aggregates with rock fragments. Some of the mortars have the ceramic content and lime lumps. Two samples include gypsum which could be also proved by Raman and XRF analysis. According to TGA analysis except two samples, they have hydraulic properties.

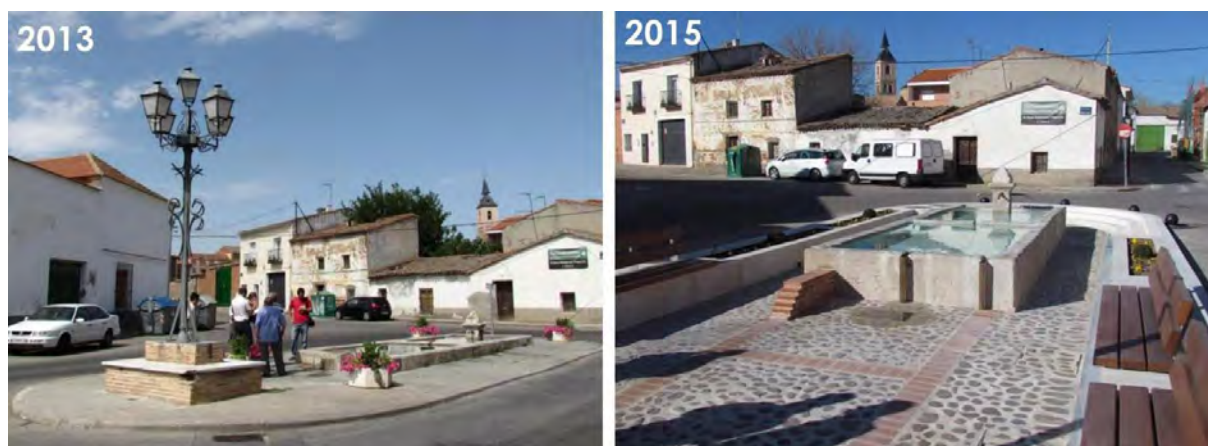
Figure 1. Image of the Fountain Square, comparing pre- and post- restoration states (2013 vs. 2015)

Figure 1 shows the image of the fountain square, comparing pre- and post-restoration states.

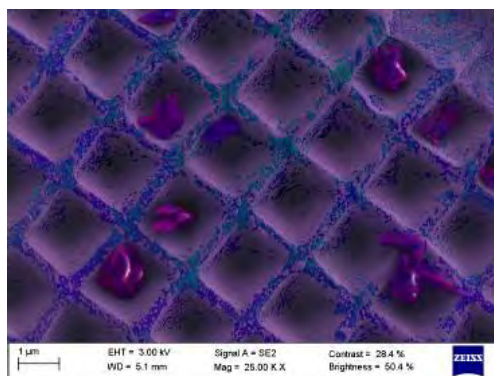
Figure 1: SEM images of a mould replica (scale bar = 1 µm) in false colour.

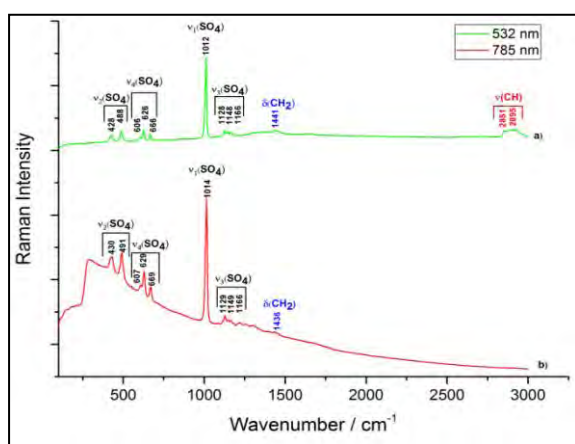
Figure 1: Raman spectra of bassenite-based egg yolk measured with two different laser excitations: a) 535 nm and b) 785 nm

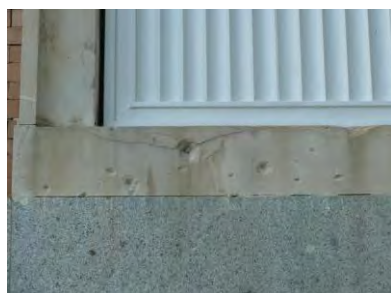
Figure 1. Shrapnel damage in the School of Medicine

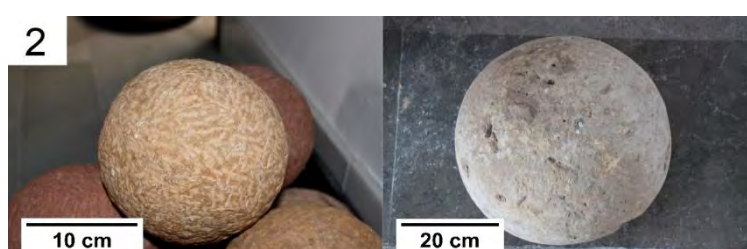
Figure 2. Gunstones with (left) and without (right) notches made by chisel

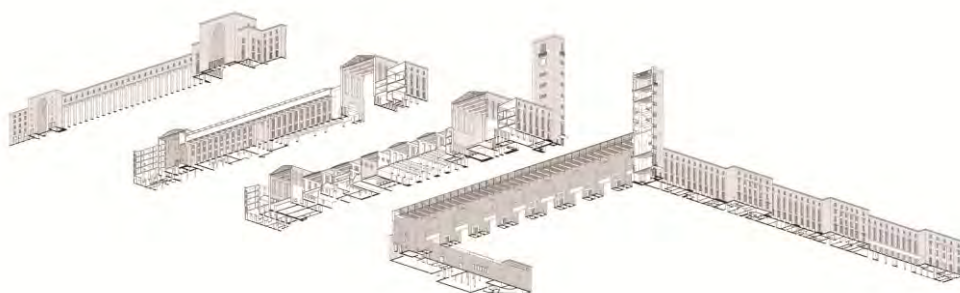
Figure 1. Axonometric section of the railway building at the time of the first version of the building (1928). Drawings by M. Balestra, M. Carbone, L. Fornarelli, F. Franciolapilla, L. Musaio Somma, A. R. Saponara, F. Strada

Figure 1 shows the 3D reconstruction of the building, as it appeared in 1928.

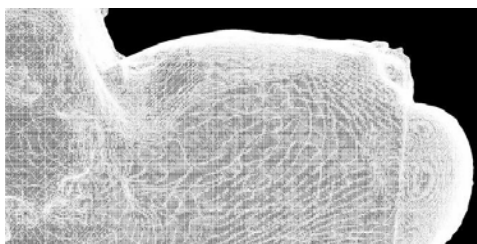
Figure 1. The main cave Church, detail (of a 3D Scanning (2015))

Figure 1 shows an image of a 3D Scanning of the main cave church (2015).

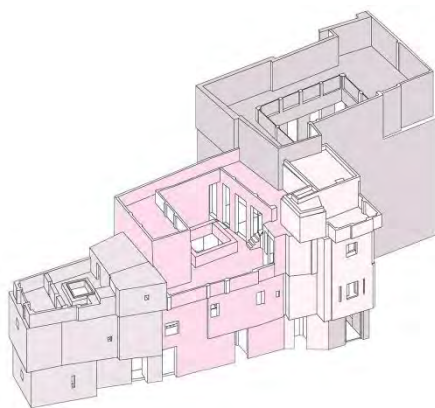
Figure 1. Axonometric of the study sample

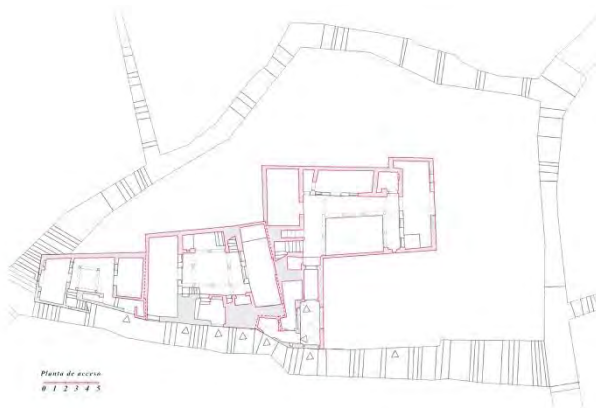
Figure 2. Plan of the study sample, four adjacent houses in the Casbah

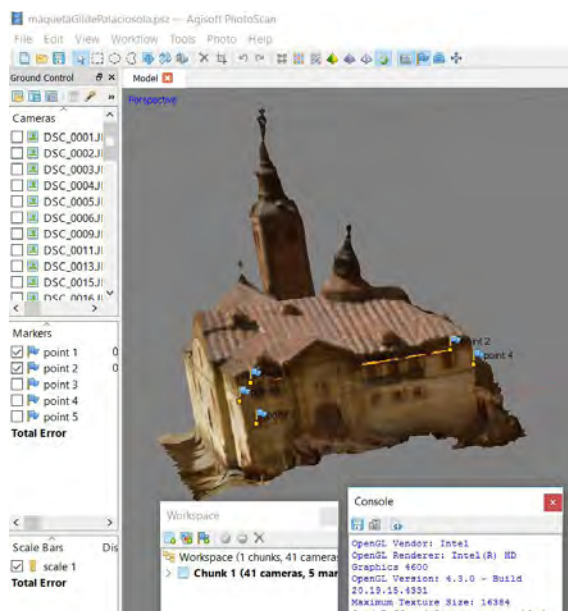
Figure 1. Santa María de la Almudena Church. Photoscan 3D model reconstruction

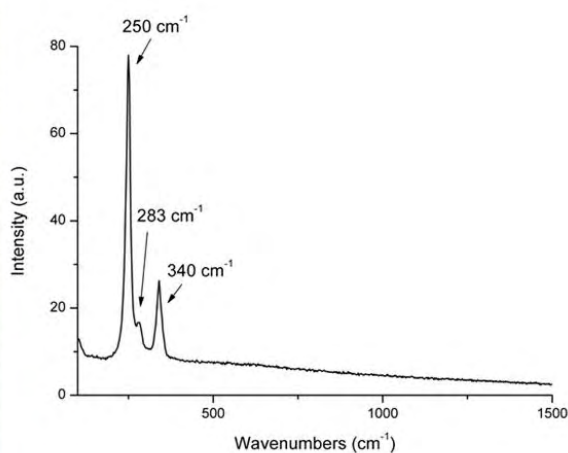
Figure 2. Raman spectrum of cinnabar

Figure 1 shows an image of one of the archaeological finds whereas figure 2 shows the obtained Raman spectrum for cinnabar.

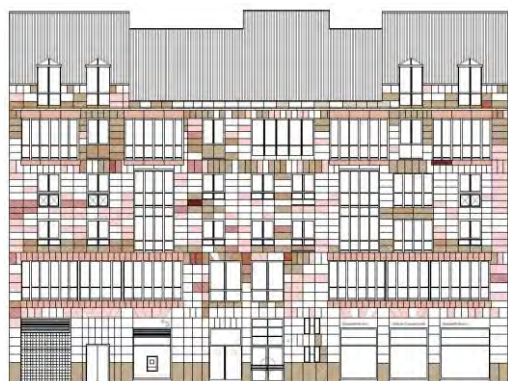
Figure 1. The stone, installed twenty-five years ago, has damages at different stages of evolution, showing in some areas a high degree of alteration while in others it remains in good condition
